# **RENGALI MULTI-PURPOSE PROJECT :**

**Across River Brahmani, Odisha**

**RENGALI MULTI-PURPOSE PROJECT :  
A BOON FOR ODISHA**

**Indian National Committee on Surface Water (INCSW)**

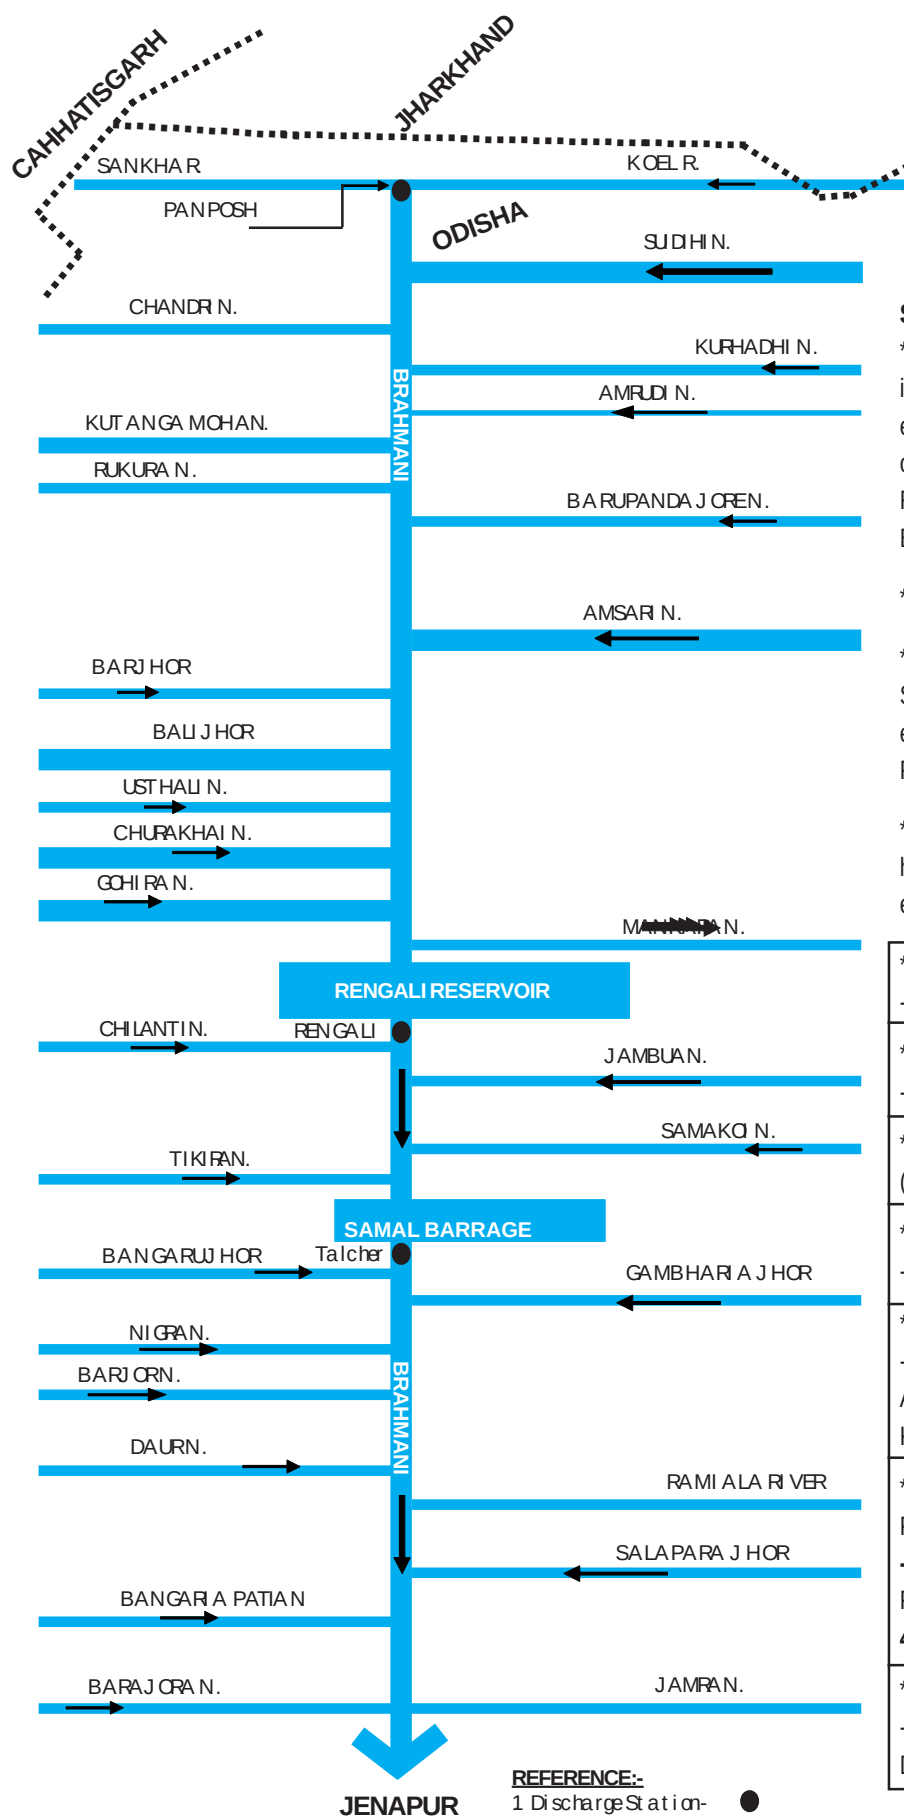
## Drg. No- 1.2(a) Schematic Diagram of river Brahmani (Upper Reach)

### Salient Feature

\* Brahmani rises near village Nagri in Ranchi district of Jharkhand at an elevation of about 600m in the name of Koel to finally meet with Sankha at Rourkela when both flow together as Brahmani.

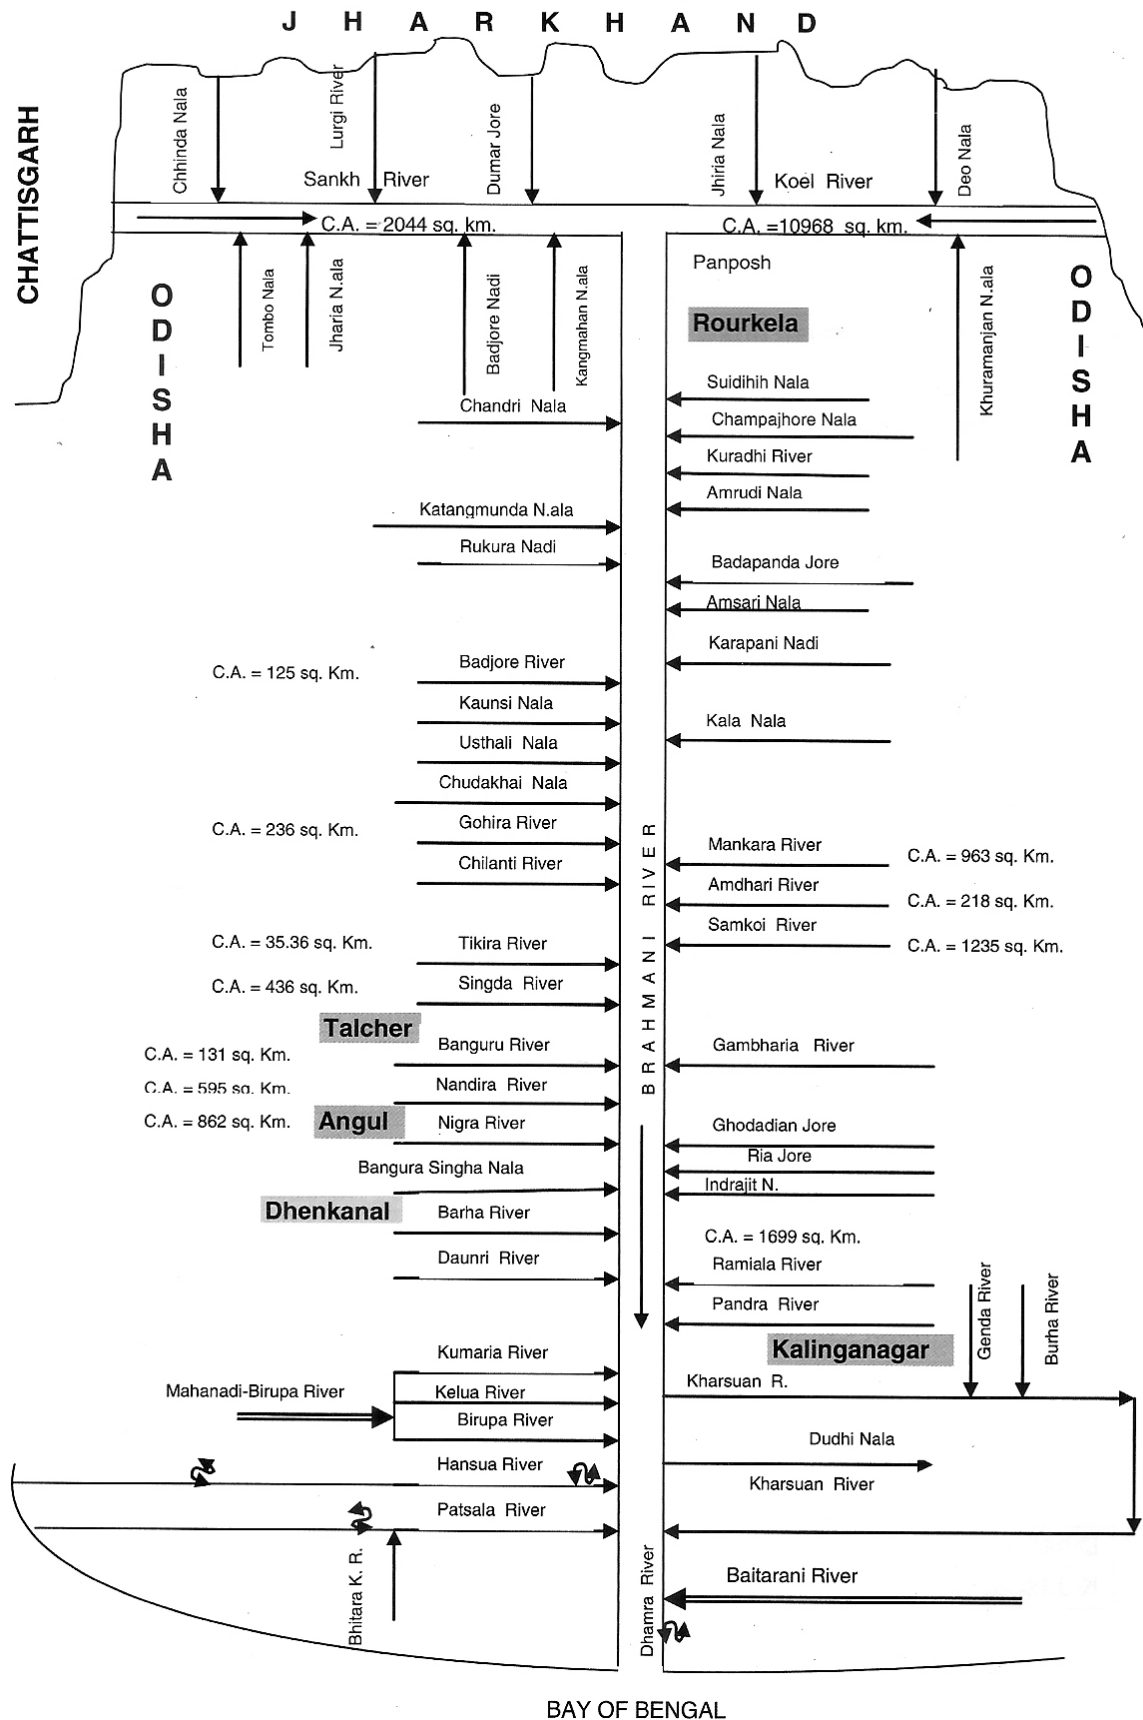
Fig. 1.8 Schematic Diagram of Brahmani River System indicating major towns and industrial area

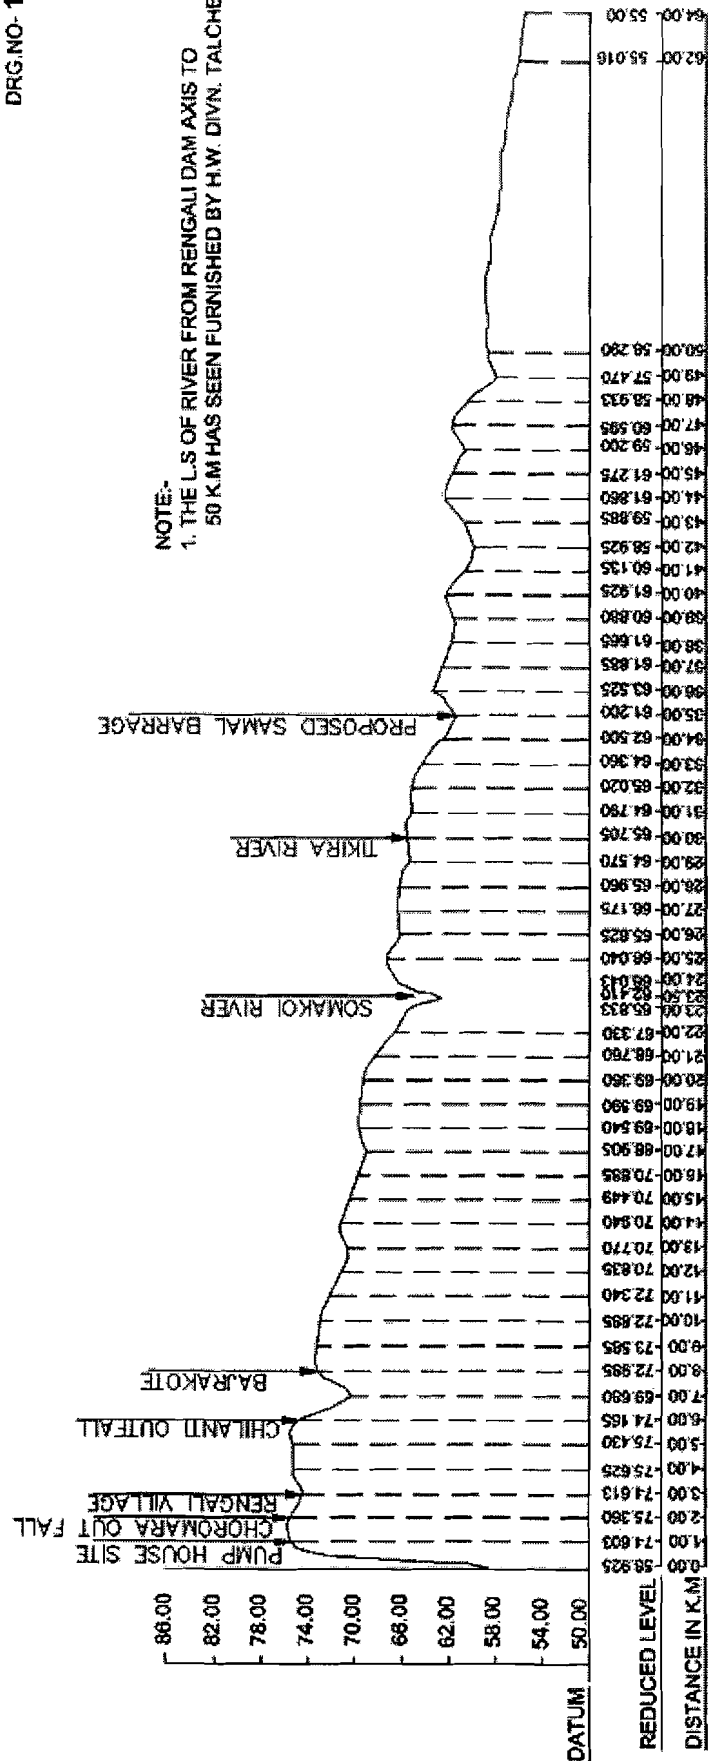
DRG.NO- 1.3

1. THE L.S OF RIVER FROM RENGALI DAM AXIS TO 50 K.M HAS BEEN FURNISHED BY H.W. DIVN. TALCHER

DETAILS L.S OF RIVER BRAHMANI FROM RENGALI DAM AXIS TO TALCHER BRIDGE SITE

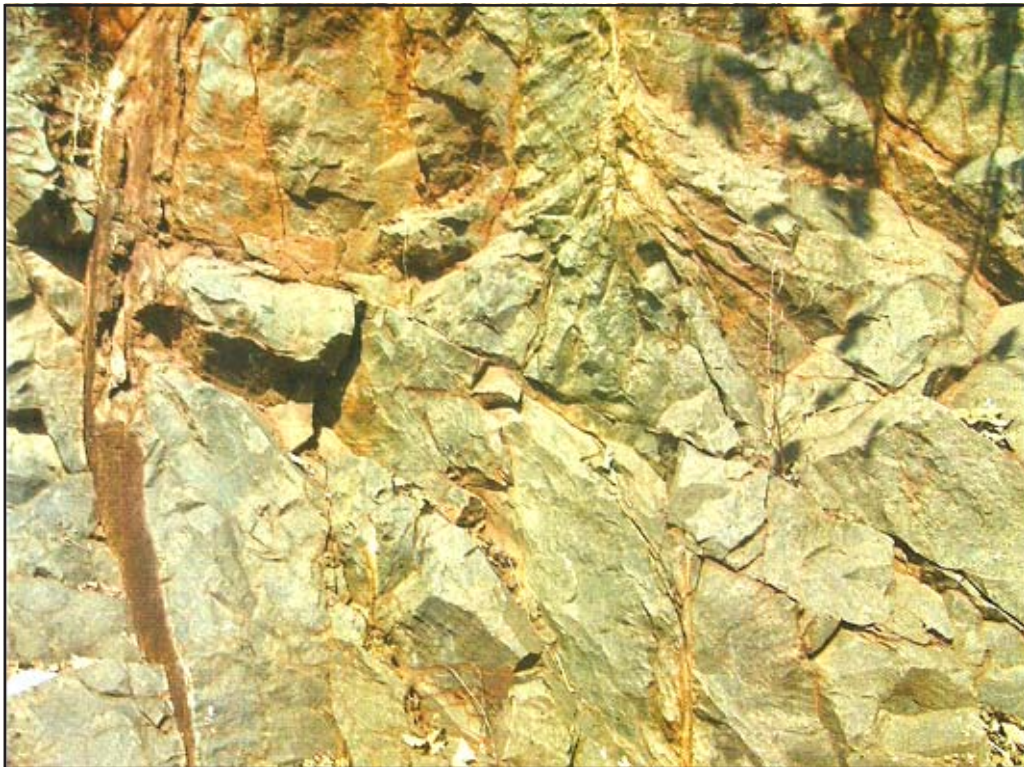
Above all, Rengali Dam foundation is one of the excellent foundations gifted by nature for construction of a 60m high gravity dam. The site being free from major defects has not posed any serious foundation problem during construction.

**Exposed charnockite near the right abutment of Rengali dam**

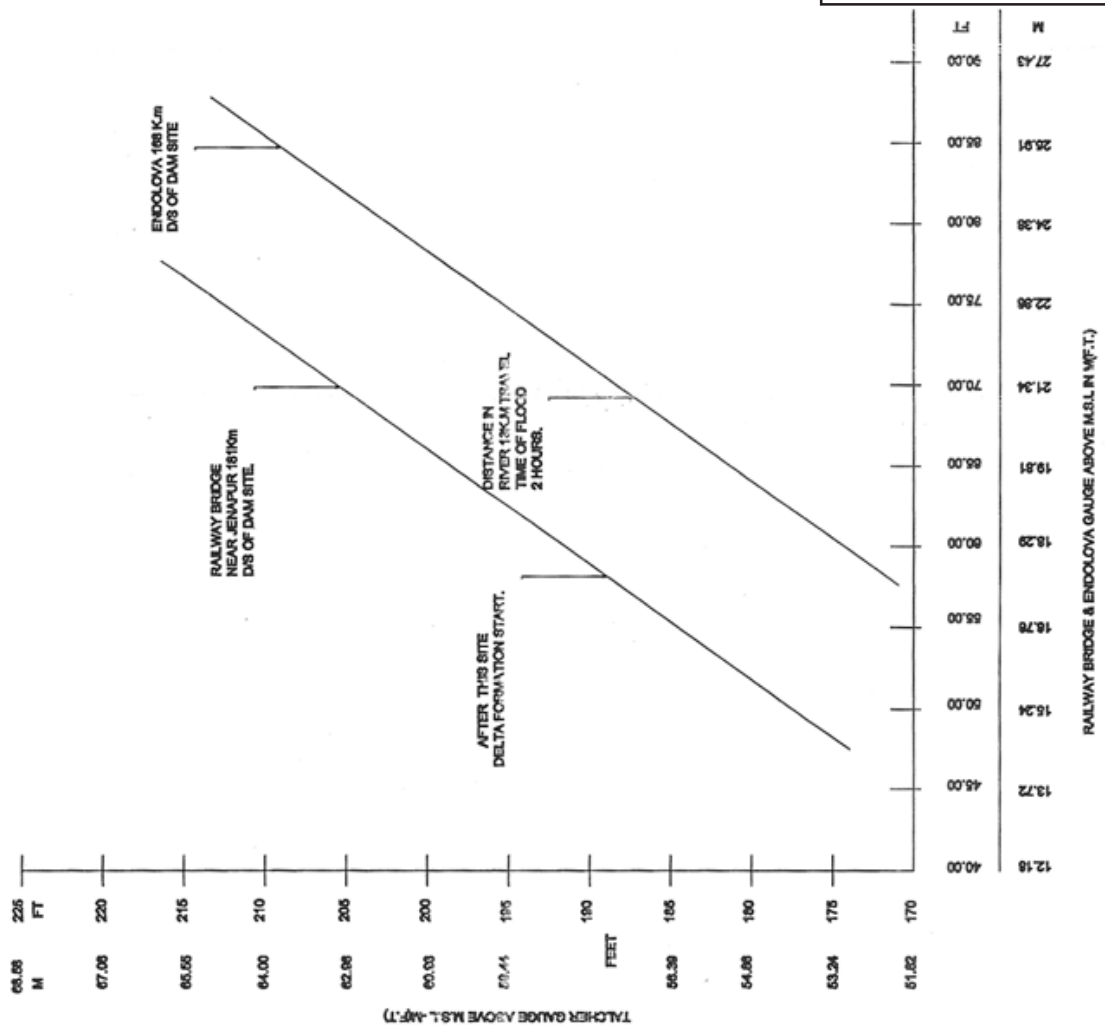
GAUGE CORRELATION OF  
JENAPUR RAILWAY BRIDGE  
AND ENDOLVA GAUGE  
AGAINST GAUGE AT  
TALCHER

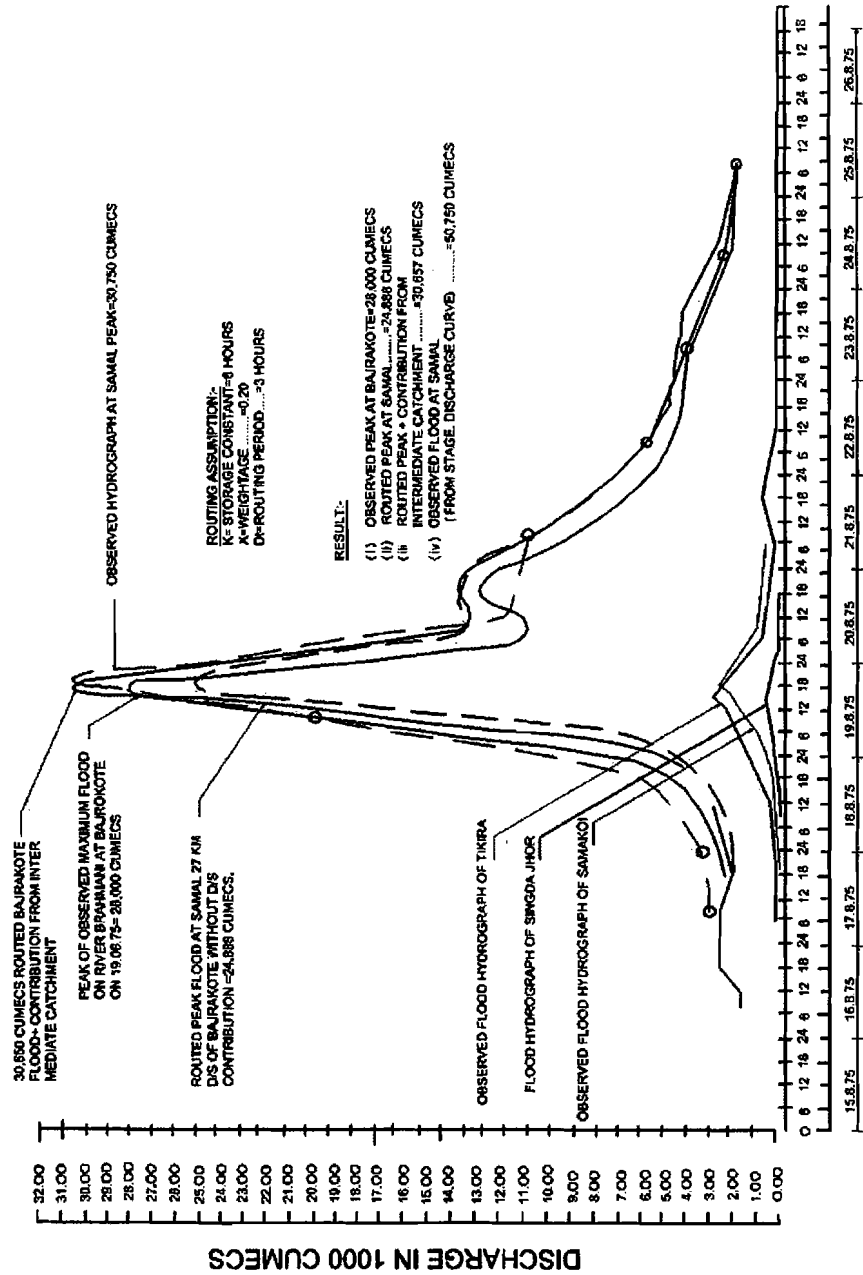
DRG NO. 2.6

CHANNEL ROUTING BETWEEN BAJRAKOTE AND SAMAL BY MUSKINGHAM METHOD

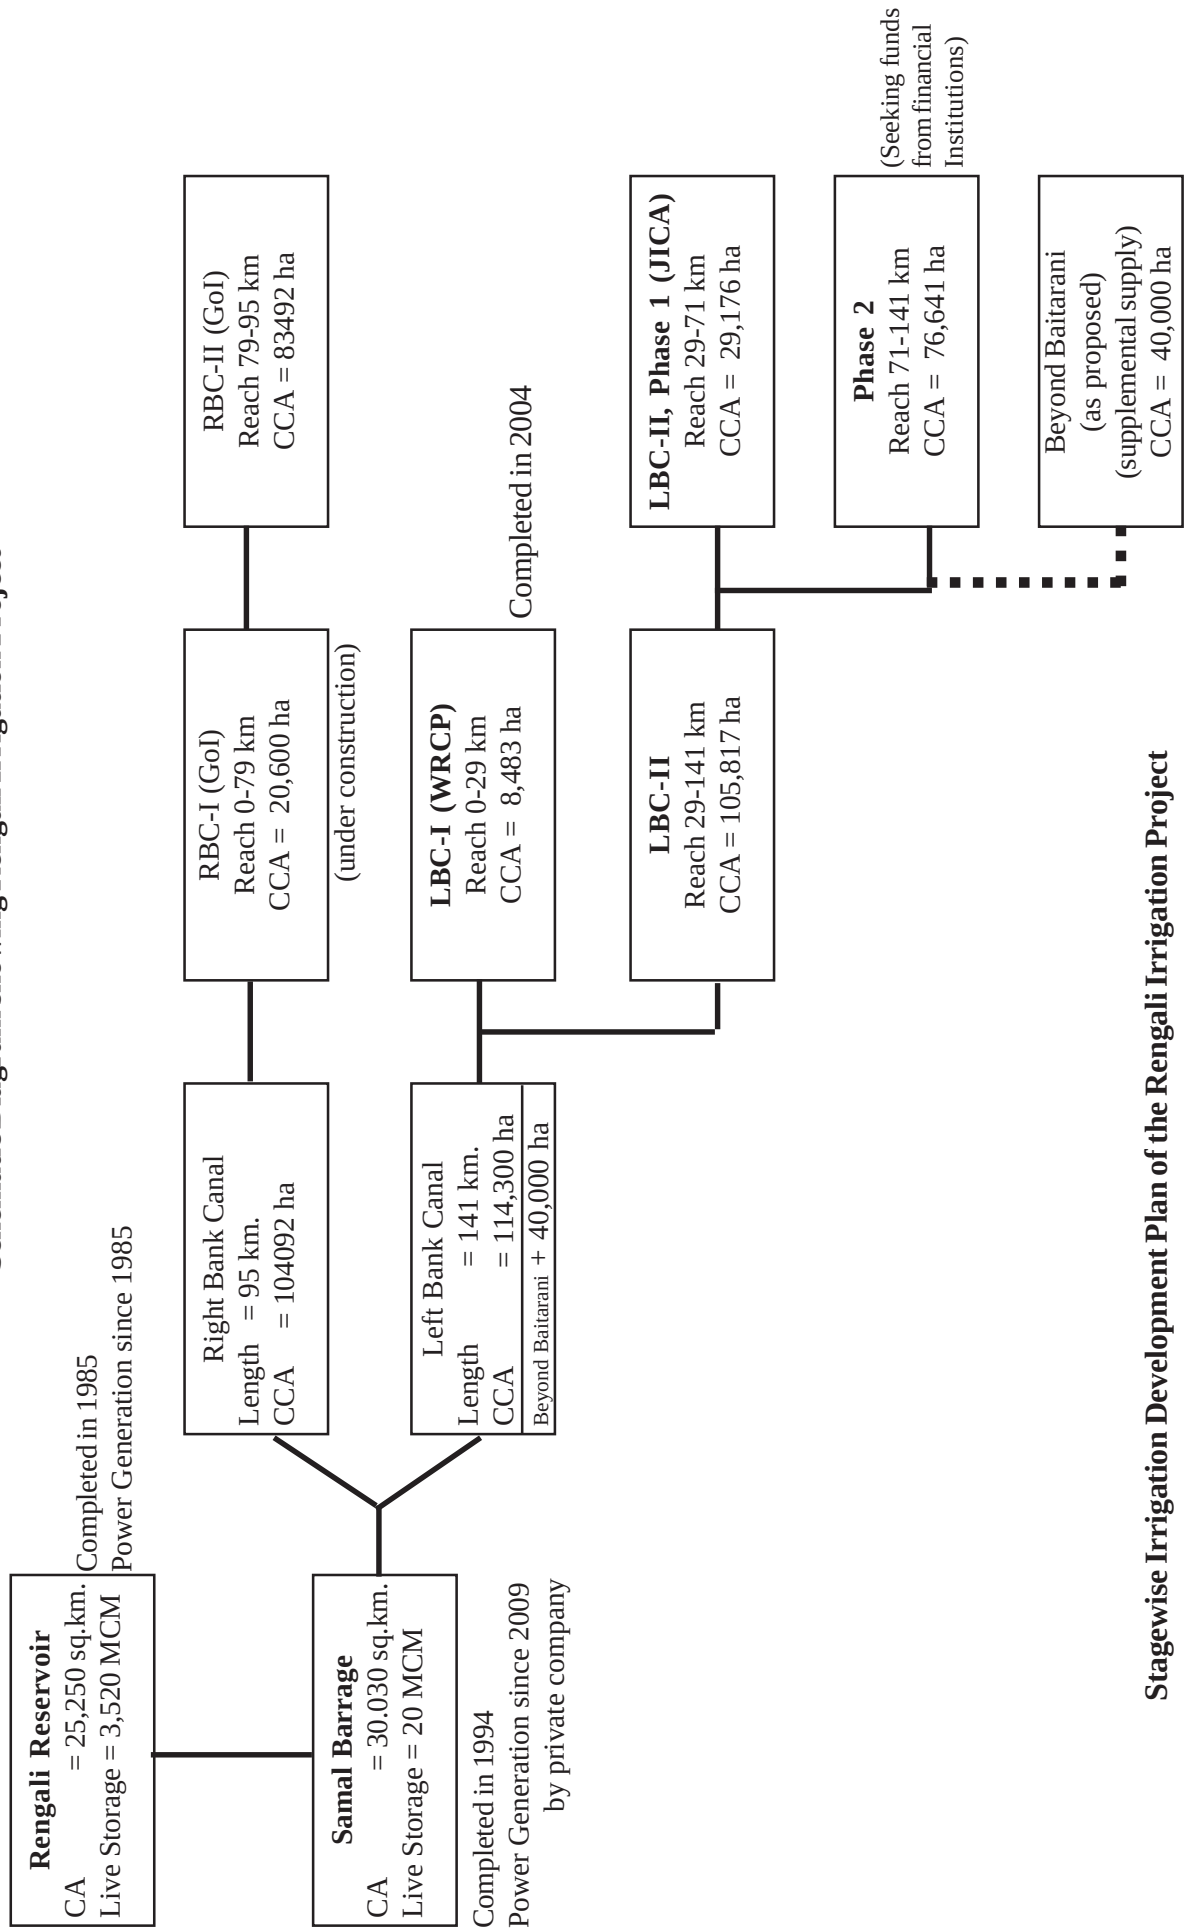
**Schematic Diagram showing Rengali Irrigation Project**

Schematic diagram of R.I.P showing details of Head works, LBC and RBC is annexed herewith.

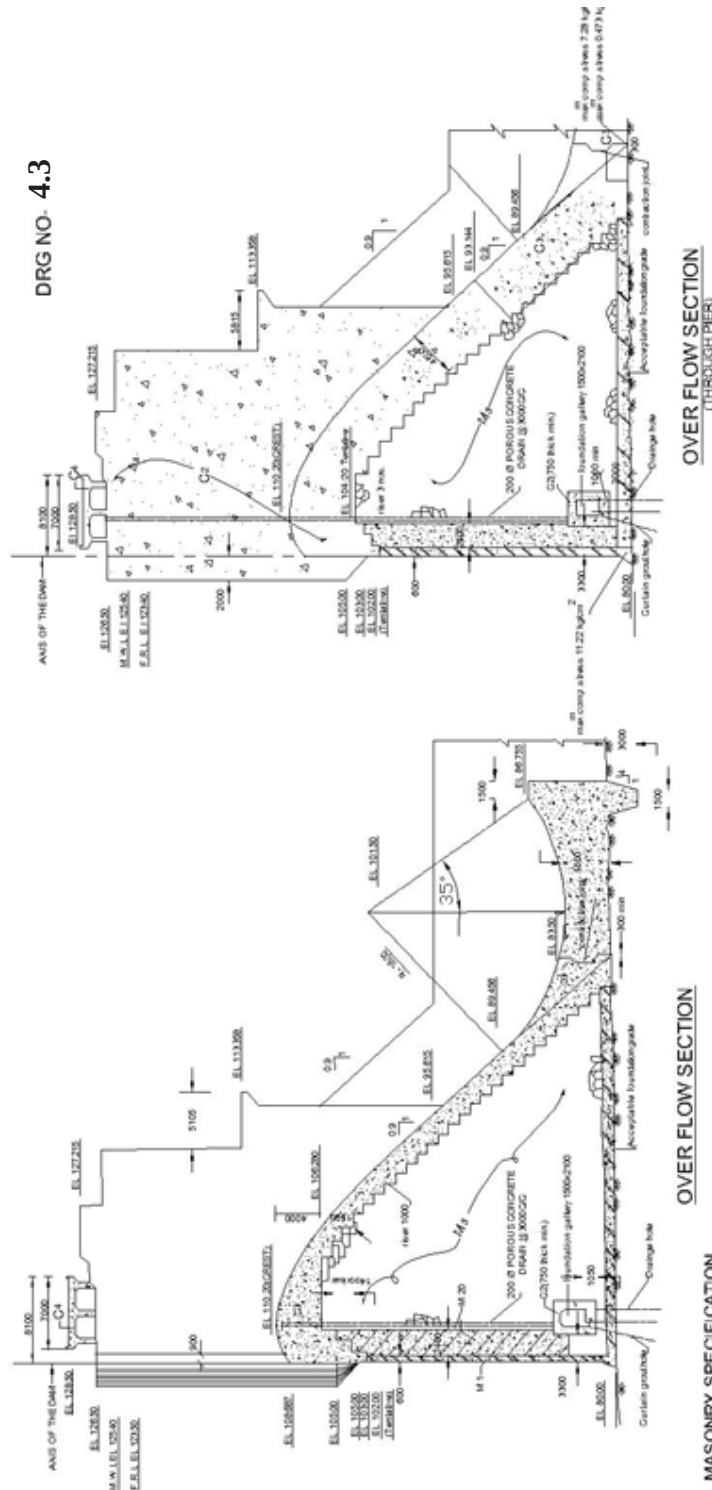
DRG NO- 4.3

OVER FLOW SECTION  
(THROUGH PIER)

OVER FLOW SECTION

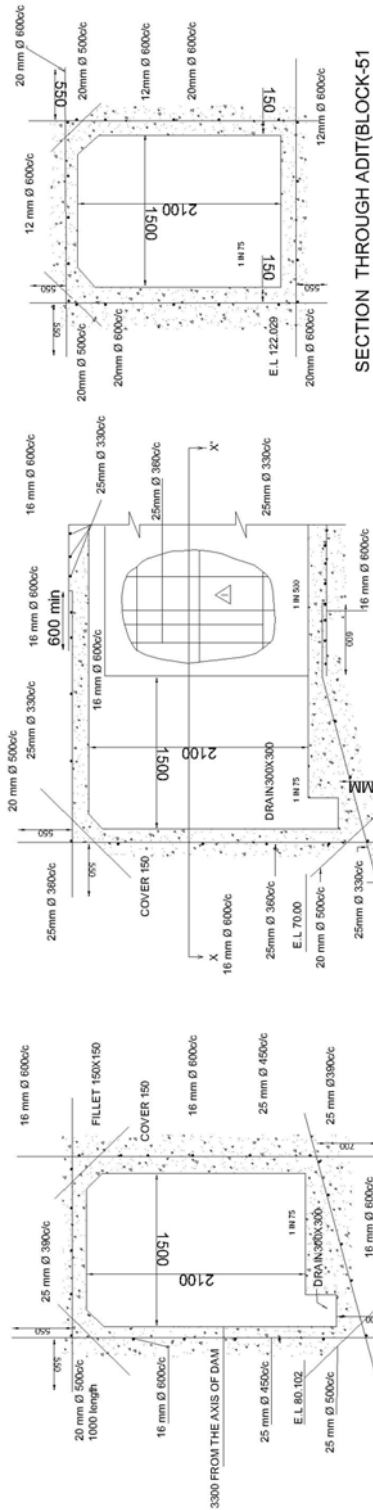
DRG. NO.- 4.7

CROSS SECTION OF GALLERY AT Ch 236 (BLOCK 12)

SECTION THROUGH C.L. OF CROSS GALLERY (BLOCK 15)

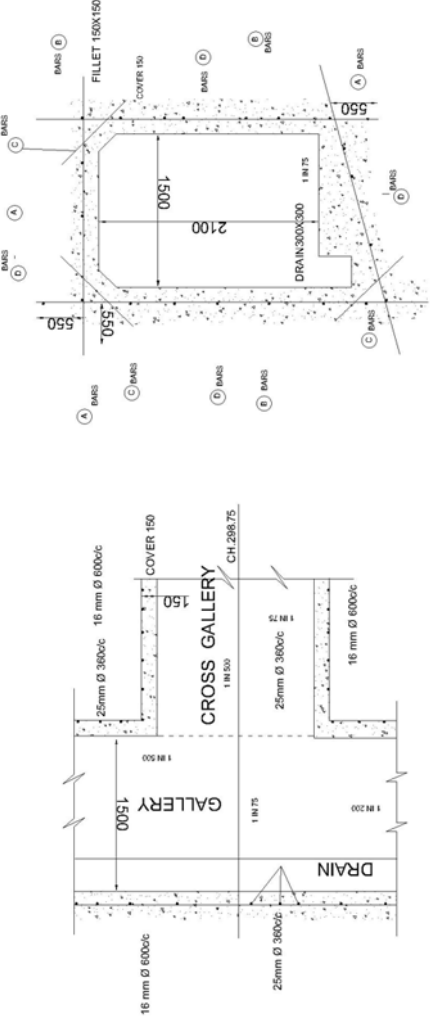
SECTIONAL PLAN OF CROSS GALLERY AT:X-X

GENERAL SECTION THROUGH GALLERY

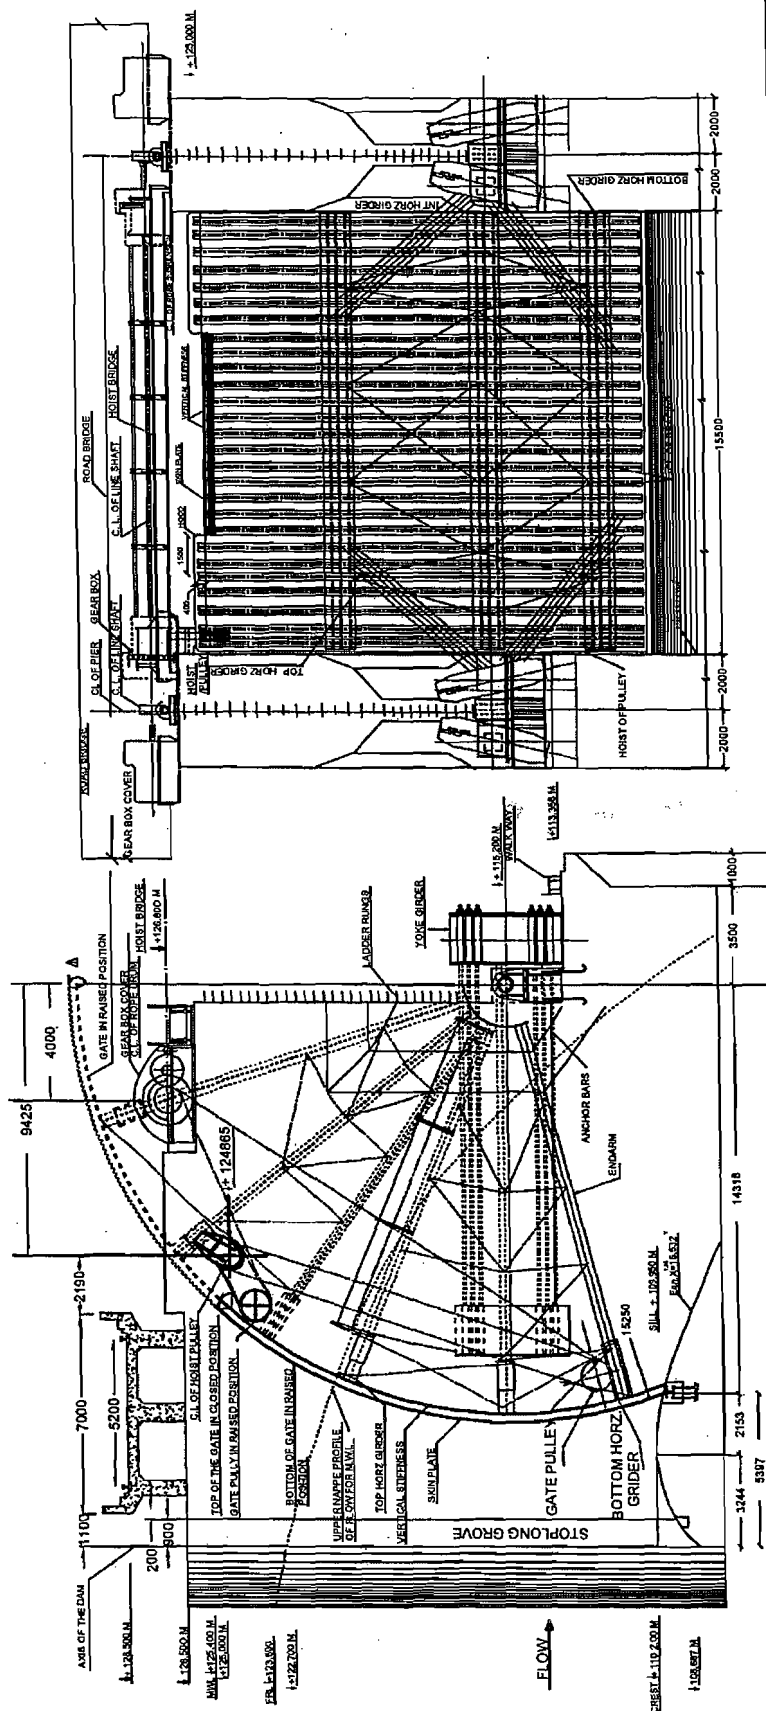
**RENGALI DAM PROJECT  
SPILLWAY GATE**

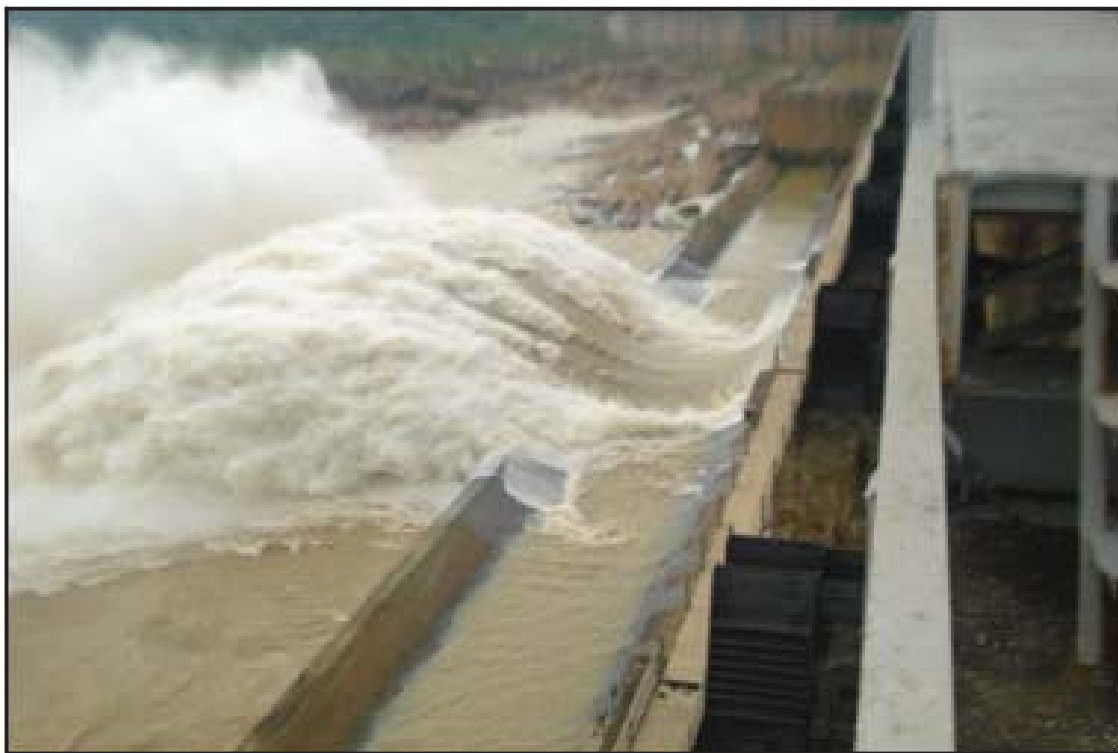
**Rengali Dam showing Ski-jump Bucket and Hydraulic Jump**

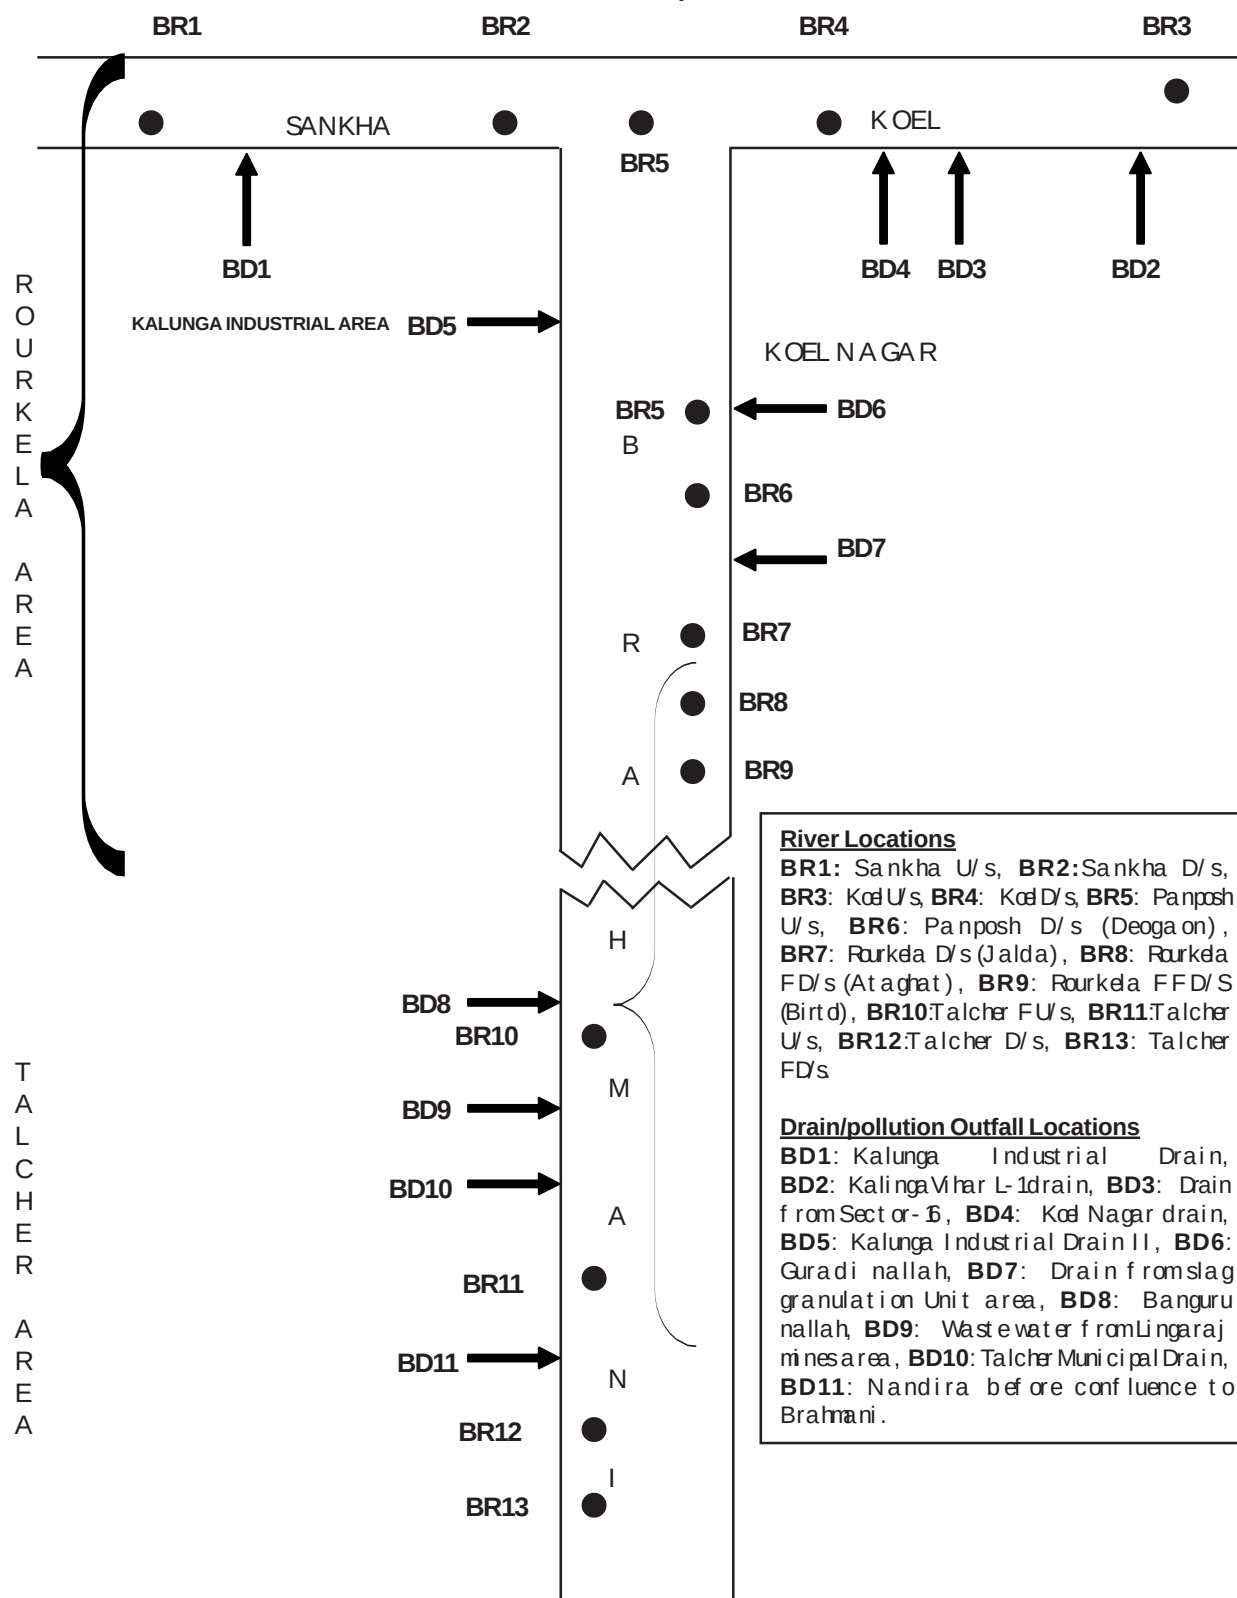
**Fig. 5.2 Schematic Diagram of Wastewater outfalls on River Brahmani along Rourkela and Talcher City**

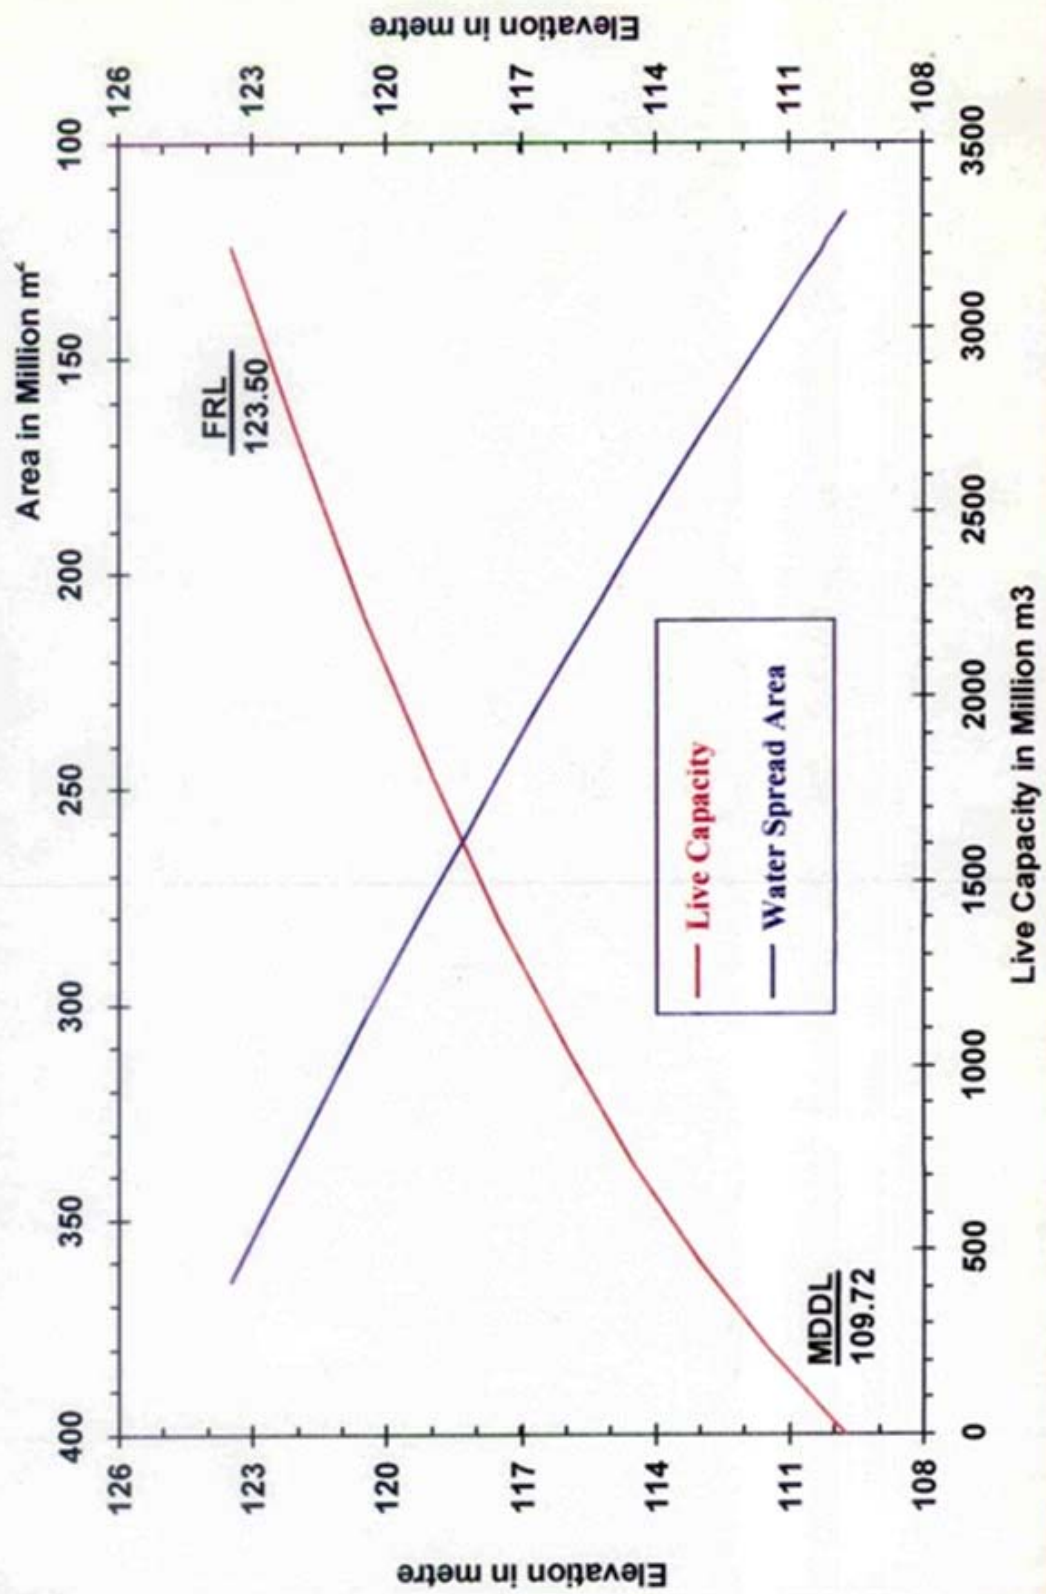
Fig. No.6.4 RENGALI RESERVOIR : MODIFIED ELEVATION-AREA-CAPACITY CURVE (2002)

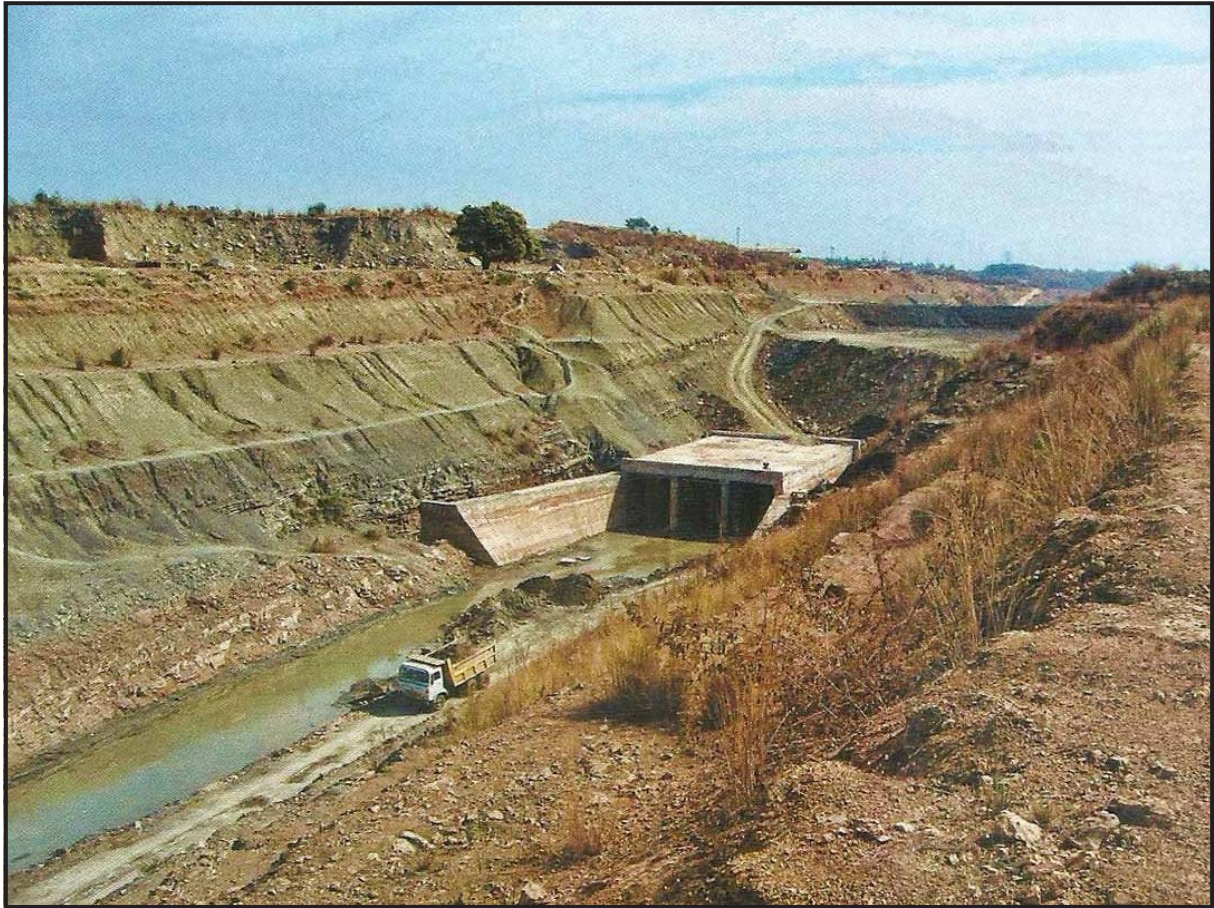
**View of Cut and Cover provided at the deep cutting section of LMC**

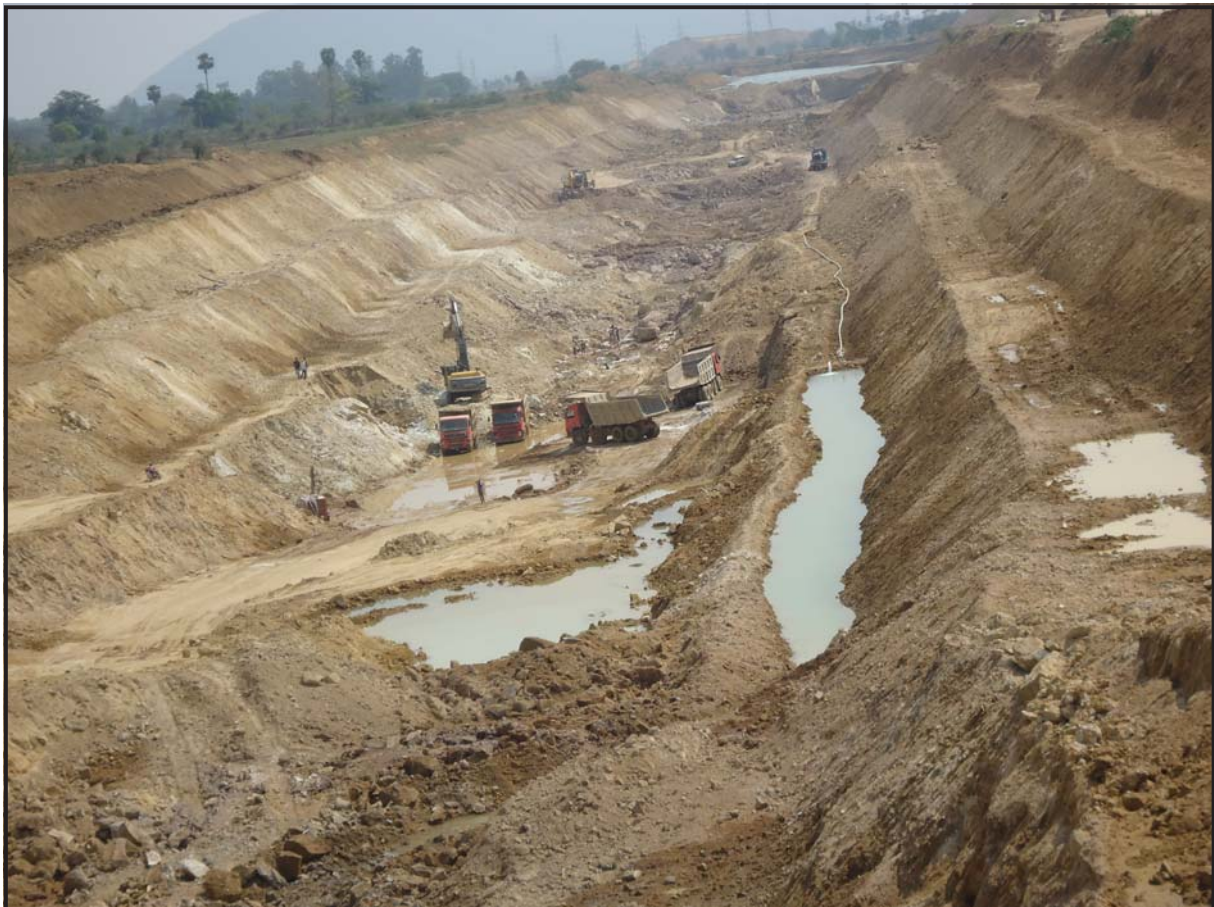
**Excavation of RMC from RD.87 km to 89 km in progress**

“The upstream excavated stretch between RSs 86500m – 87350m exposed mainly moderate to highly weathered khondalite. The bed rock is defined by pink to pinkish brown coloured Khondalite with later mafic veins and dykes. The soil mass thickness vary from 2.0m to 3.0m. The later intrusive generally define network of veins almost through out the Khondalite rockmass. The veins vary in thickness from a few millimeters to ten centimeters. They are generally weathered to white to greenish clay mass. Minor bands of white quartzo – feldspathic bands are also present in the upstream part. In general, the rock mass condition improves towards downstream with the decrease in the intensity of the clay vein network. This has resulted in chaotic admixture of moderately weathered and highly weathered rock mass occurrences. The site officials have reported a difficulty in excavation of such a rock mass by way of existing mechanized excavation for which site demo was also undertaken at places. It was observed that at most of the places the excavator’s (Kobelco 210) bucket could produce only 5-10cm deep grooves instead of strapping the surface. In this regard, based on above observation it has been felt that as the excavation has to go further deeper by another 15m the blasting can be one of the best mode to facilitate the excavation process. However, in view of the chaotic admixture of moderately weathered stiff and D.I. rock masses, their amenability to blasting has to be tested by trial blasts in selected sections. However, it is also suggested that in addition to the index properties, the rippability and blastability index may also be determined. It is suggested that the interpretation of data and the trial blast must be conducted in consultations with the concerned experts and the geologist. The excavated stretch between RD 87350 m – 87900 m was water filled and hence could not be observed.
